Phase I Environmental Site Assessment,
3353-3359 Lakeshore Boulevard West,
Toronto, Ontario

Reference No.: TT05753.1
Date: March 22, 2019

TankTek
Environmental Services Ltd.

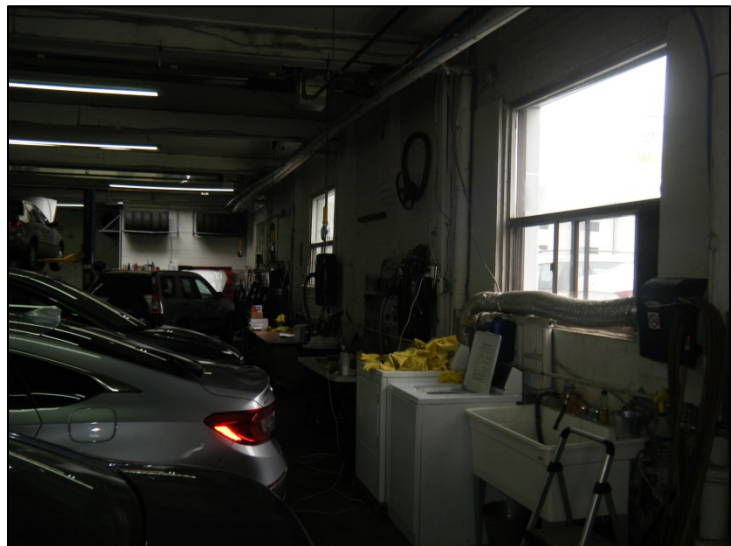
Photo 3:

View of the hydraulic hoist with aboveground oil reservoir in the Hi-Line Auto garage area. Photo taken facing south.

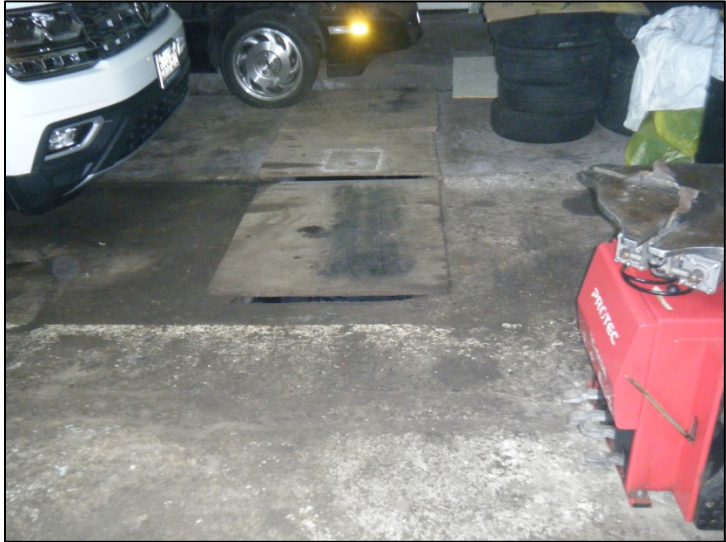
Photo 5:

A small manhole cover was observed within the southern portion of the auto repair garage occupied by Hi-Line Auto Centre. Beneath the cover was a capped steel pipe that had a diameter of 5 cm. It is not known if the pipe is associated with an underground storage tank (UST), or is connected to the floor trench and floor pit located just east of the pipe. No other evidence of a UST (e.g. vent or fill pipes) was observed on the Site.

- A 5 cm diameter capped steel pipe was observed within a covered manhole at the southern portion of the auto repair garage at 3353 Lakeshore Boulevard. The pipe was located in the near vicinity of the floor pit outlined above. It is not known if the pipe is associated with the floor pit, the former spray booth, or an underground storage tank, etc.

View of the 5cm diameter capped steel pipe at the south end of the Hi-Line Auto garage. Photo taken facing northeast.

- Due to the current and historical tenancy of the Site (by various auto repair facilities and a retail fuel facility), an intrusive subsurface environmental investigation (Phase II ESA) is considered warranted to evaluate the soil and groundwater quality on the Site.

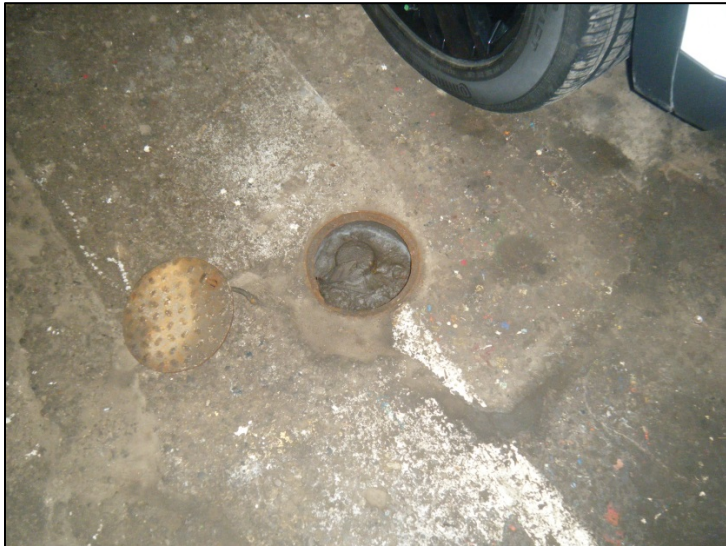
Photo 6:

A floor drain was observed in the middle of the auto repair garage area of the easternmost building. A floor trench (covered with plywood) and floor pit were observed at the southeast corner of the garage. The trenches and pit were reported by the tenant to be an oil-water separator system. The tenant also noted that the pit and trenches were located at the approximate former location of a paint spray booth. The pit is reportedly pumped out approximately once per year. The pit was full of water at the time of TankTek's Site visit. No debris was observed in the vicinity of the floor drain and floor trench/pit.

View of the floor drain in the middle of the garage area of Hi-Line Auto. Photo taken facing north.

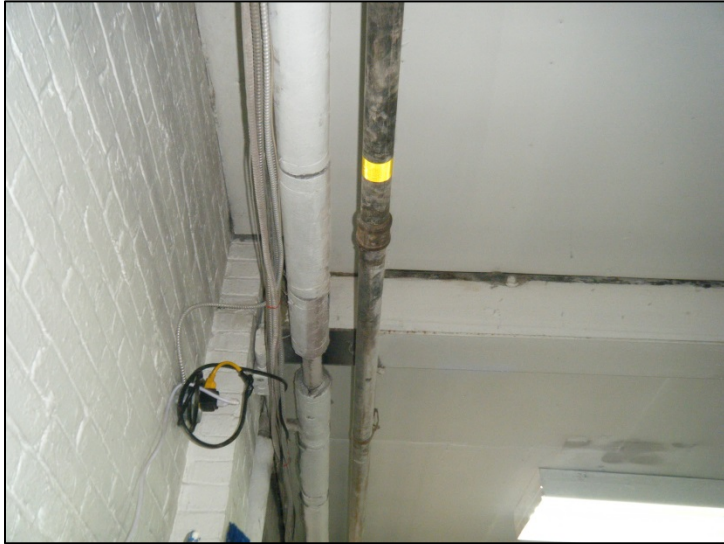
Photo 7:

Pipe insulation was observed within the auto repair garage of the easternmost building (occupied by Hi-Line Auto Centre) that was suspected to be asbestos-containing material (ACM). The insulation was observed on piping affixed to the ceiling along the eastern and western sides of the building, and within a storage closet at the far southwest corner of the building. No other suspected friable ACMs were observed.

- Suspected friable asbestos containing materials (ACMs) include pipe insulation observed within the auto repair garage area and within a storage closet of the easternmost building (3353 Lakeshore Boulevard West). Non-friable materials may include vinyl floor tiles, exterior caulking, drywall joint compound and roofing and mastic materials.

View of a section of the insulation on the piping affixed to the ceiling that runs along the east side of the Hi-Line Auto garage. Photo taken facing south.

- Suspected to be asbestos-containing materials (ACMs) are recommended to be sampled and analyzed to confirm the presence/absence of ACMs. Identified ACMs (friable and non-friable) should be removed, or a management plan developed, in accordance with Ontario Regulation 278/05.

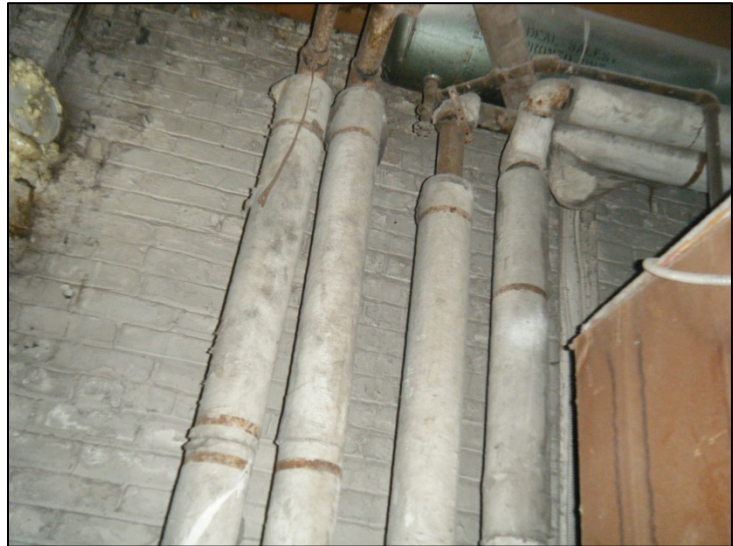
Photo 8:

View of the pipe insulation within the storage closet at the southwest corner of the Hi-Line Auto garage. Photo taken facing west.

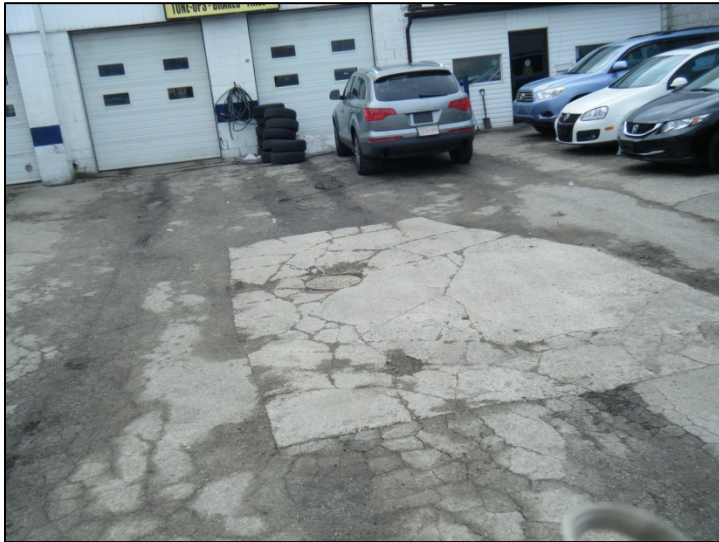
Photo 18:

Three pipes were observed to protrude vertically above the asphalt within the parking area to the north of the westernmost building. The pipes were equally spaced from near the building to near the northern Site boundary, and all located along the western Site boundary, approximately 1 m east of the western abutting building, and had approximate diameters of 75 mm. The pipes had all been cut to near flush with the paving and were filled with soil. It is not known if these pipes were formerly used as posts, or are associated with underground storage tanks.

View of one of the three pipes cut near flush with the asphalt, along the west Site boundary at 3359 Lakeshore Boulevard West. Photo taken facing south.

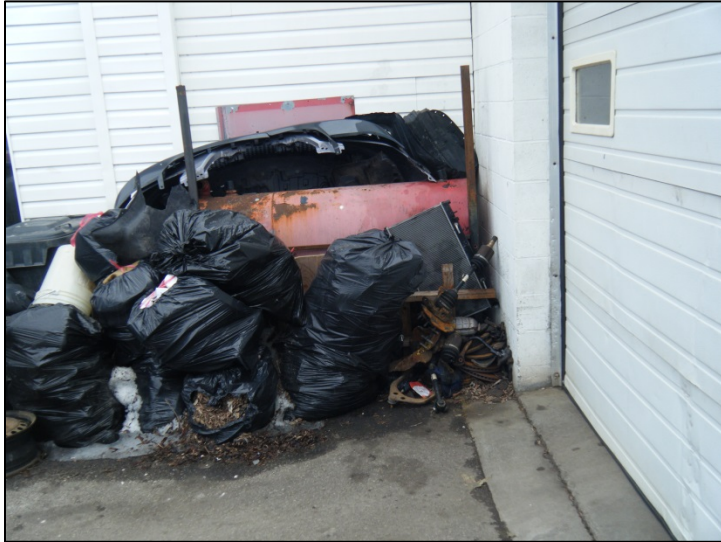
Photo 19:

An AST was observed at the north exterior of the building occupied by Angora Auto Sales. The AST had a capacity of approximately 910 L. No evidence of leaks or staining on the ground surface were evident. Several bags of garbage had been stockpiled on and in the near vicinity of the AST.

View of the aboveground storage tank located adjacent to the north exterior wall of the Angora Auto Sales building. Photo taken facing east.
