Arborist Report

3353 and 3359
LAKESHORE BLVD.
WEST

November 14, 2019

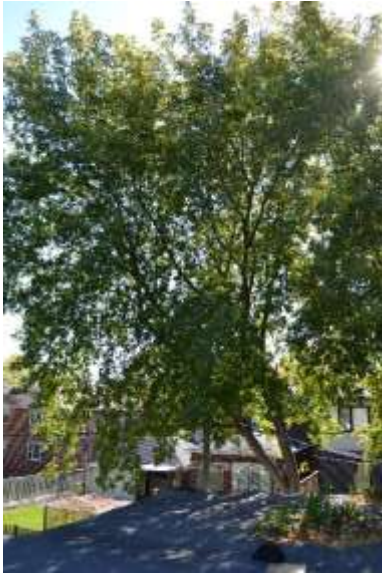
Tree 1 - canopy

Tree No.	Species	DBH (cm)	Canopy Wicth ² (m)	Crown Class	Biological Vigour ³	Structural Health ⁴	Notes ⁵	Recommended Action ⁶	Category ⁷
1	Acer negundo	~45	10	D	H	ML	IB @ main union. Large wound from 2m-3m ht. with 15%TD. 3 small wounds at 4m ht. with 5%TD. Rubbing wound on telephone pole at 7m ht. Leans 30° east.	Remove for poor condition with neighbour's approval	2
2	Acer negundo	~15	7	I	H	ML	Large rubbing wound on telephone wires with 40%TD. Leans 20° east.	Remove for construction with neighbour's approval	2
3	Acer negundo	~50	10	D	H	ML	Large limb pruned at main union. Many epicormic sprouts @ 3m ht. telephone wire rubbing wound at 7m ht. Wire caught in IB at main union. Large wound at 1m ht. with 15%TD.	Remove for construction with neighbour's approval	2
4	Acer negundo	~30, ~30	8	D	H	L	FFB on large cut stump (1m ht.). Co-dominant leaders. Many pollarded branches where tree is over building. 1 leader leaning on fence, 20° lean to west.	Remove for poor condition with neighbour's approval	2

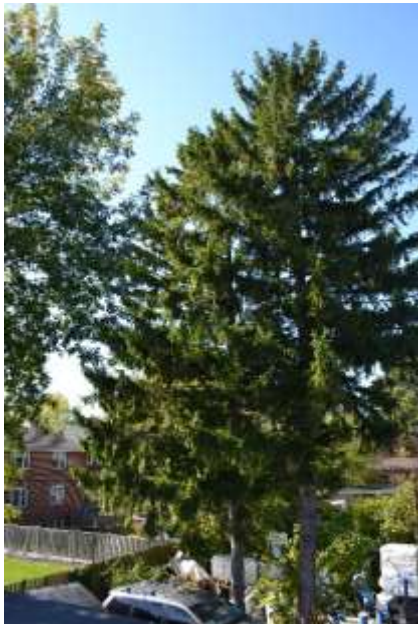
Trees 5 and 6 - canopy

5	Picea abies	41	6	C	H	H	Pruned up to 5m	Remove for construction with neighbour's approval	2
6	Picea abies	53.5	7	C	H	H	Pruned up to 10m in parts. One large pranch stub left unpruned.	Remove for construction with neighbour's approval	2

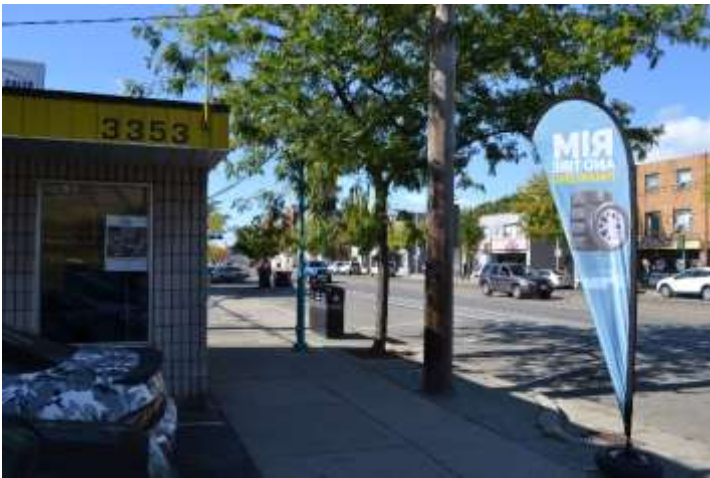
Tree 7

Tree No.	Species	DBH (cm)	Canopy Wicth ² (m)	Crown Class	Biological Vigour ³	Structural Health ⁴	Notes ⁵	Recommended Action ⁶	Category ⁷
7	Gleditsia tiracanthos var. inermis	24	10	D	M	M	Boulevard tree. Growing over concrete block at base creating wound with 25%TD. Wound on branch over street with 25% damage. There are multiple crossing branches and 1 medium sized DB with a girdling wire.	Preserve	5
8	Gleditsia tiracanthos var. inermis	23.5	8	D	M	M	Girdling wire on large branch in canopy.	Preserve	5
9	Cercidiphyllum japonicum	11.5	3	D	M	M	Small boulevard tree. Large wound at base to 50cm ht. with 25%TD.	Preserve	5

1. City boulevard trees 7 to 9 are proposed to be preserved and protected from construction activities and material handling. Trees 8 and 9 are sufficiently distant from the site not to warrant tree protection fencing. However, for tree 7 this protection must be accomplished by erecting tree protection hoarding around the tree at the limit of the open tree planter. Snow fence tree protection hoarding with wood framing should be used in order to allow for visibility to drivers and pedestrians passing by the property. The detail is shown on the tree protection plan (T.1).

2. Perform canopy pruning to clean the crowns of dead, diseased, crossing, weak, and dead wood, and to provide adequate clearance for equipment and construction. No more than 20 percent of the live foliage is to be removed from any tree. All pruning should be performed in accordance with the International Society of Arboriculture (ISA) Pruning Standard Guidelines.
3. Changes to the paving in the front boulevard of the building will have an impact on tree #7 due to the removal of existing pavement and the installation of new pavement. No work on the

paving within the tree protection zone may be conducted until the finishing stages of construction. Existing paving must remain in place throughout construction to act as a protective barrier for tree roots.

In the finishing stages of construction existing paving should be removed without bringing mechanical equipment in contact with the tree. The tree should have the trunk covered with 2"x4" lumber placed vertically along the trunk, wrapped to the trunk with layers of snow fence, and secured with metal straps. See tree wrapping detail below (figure 3). Soil that is left exposed should be covered with 10cm depth of mulch and 4' x 8' steel plates. All mulch and steel plates may be removed once new pavement is ready for installation.
