Arborist Report

3353 and 3359
LAKESHORE BLVD.
WEST

November 14, 2019

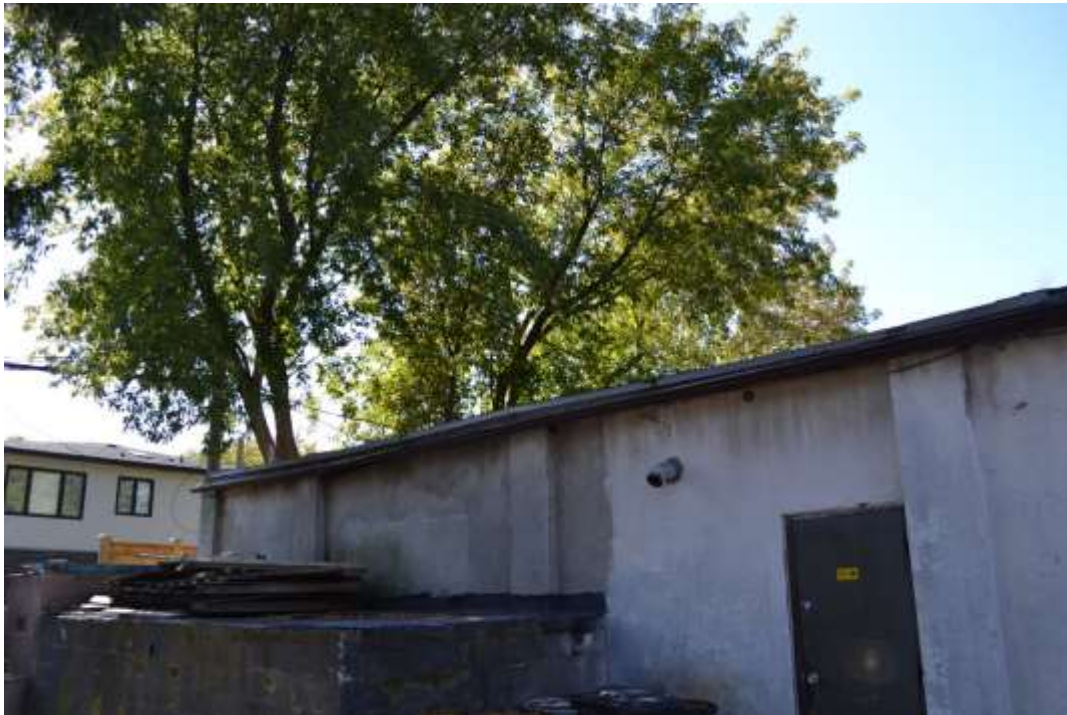
Figure 2: View of trees 1 – 3 behind existing building on neighbouring property.

Tree No.	Species	DBH (cm)	Canopy Wicth ² (m)	Crown Class	Biological Vigour ³	Structural Health ⁴	Notes ⁵	Recommended Action ⁶	Category ⁷
1	Acer negundo	~45	10	D	H	ML	IB @ main union. Large wound from 2m-3m ht. with 15%TD. 3 small wounds at 4m ht. with 5%TD. Rubbing wound on telephone pole at 7m ht. Leans 30° east.	Remove for poor condition with neighbour's approval	2
2	Acer negundo	~15	7	I	H	ML	Large rubbing wound on telephone wires with 40%TD. Leans 20° east.	Remove for construction with neighbour's approval	2
3	Acer negundo	~50	10	D	H	ML	Large limb pruned at main union. Many epicormic sprouts @ 3m ht. telephone wire rubbing wound at 7m ht. Wire caught in IB at main union. Large wound at 1m ht. with 15%TD.	Remove for construction with neighbour's approval	2
4	Acer negundo	~30, ~30	8	D	H	L	FFB on large cut stump (1m ht.). Co-dominant leaders. Many pollarded branches where tree is over building. 1 leader leaning on fence, 20° lean to west.	Remove for poor condition with neighbour's approval	2
