Phase I Environmental Site Assessment,
3353-3359 Lakeshore Boulevard West,
Toronto, Ontario

Reference No.: TT05753.1
Date: March 22, 2019

TankTek
Environmental Services Ltd.

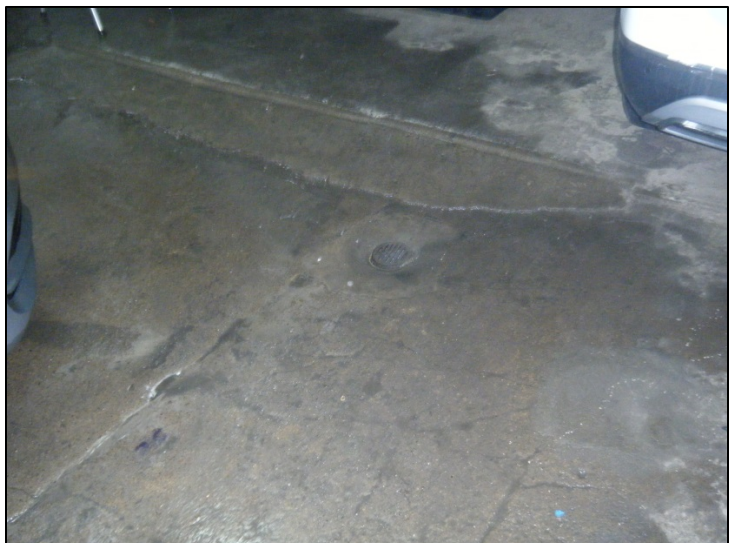
Photo 6:

View of the floor drain in the middle of the garage area of Hi-Line Auto. Photo taken facing north.

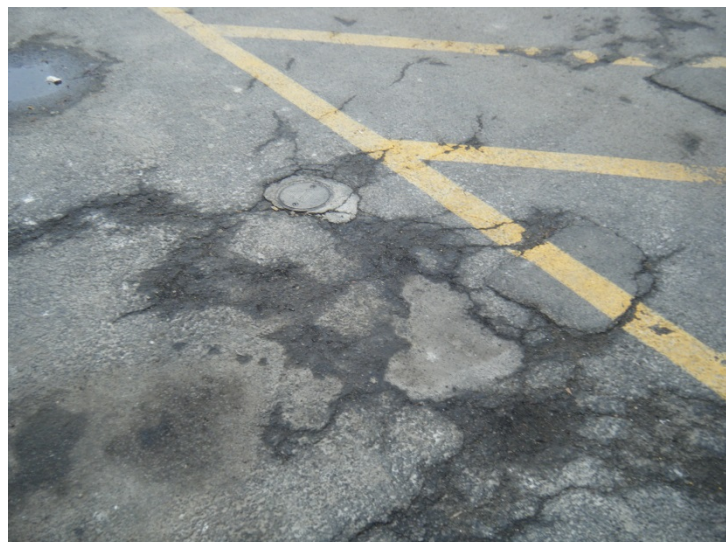
Photo 12:

View of the groundwater monitoring well located at the north exterior of 3353 Lakeshore Boulevard West. Photo taken facing northeast.

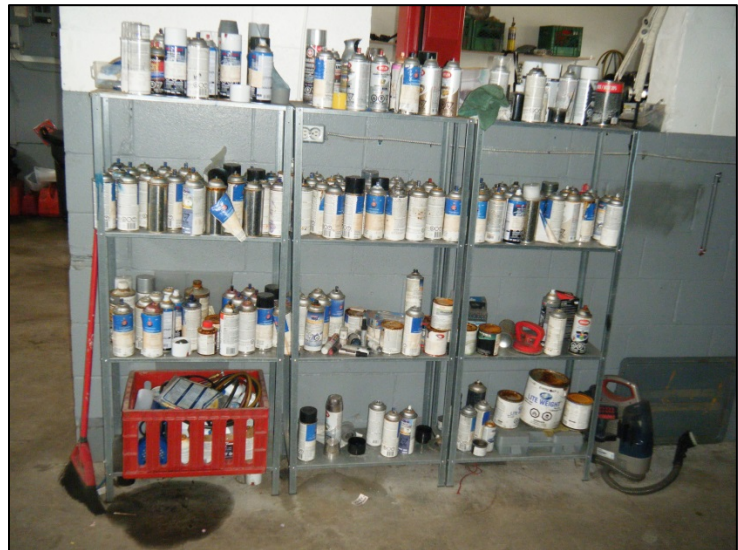
Photo 14:

View of the various paint spray containers in a storage rack within the middle garage bay at 3359 Lakeshore Boulevard West. Photo taken facing west.

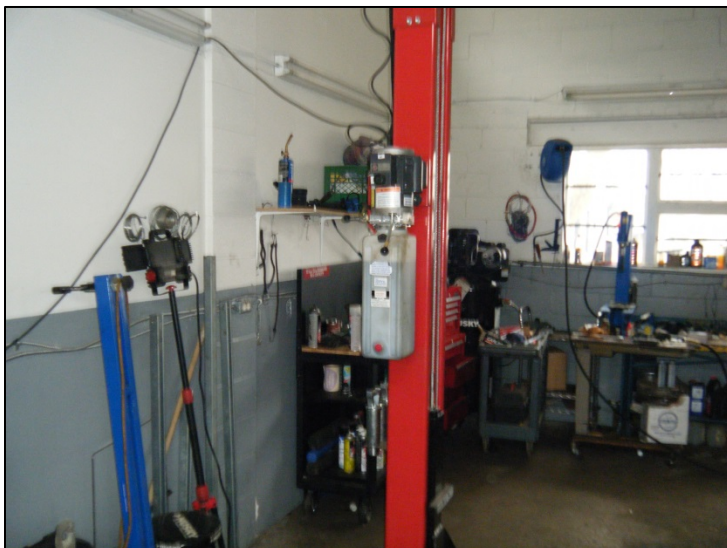
Photo 15:

View of the automotive hoist with aboveground hydraulic oil reservoir, located within the easternmost bay garage of 3359 Lakeshore Boulevard West. Photo taken facing south.

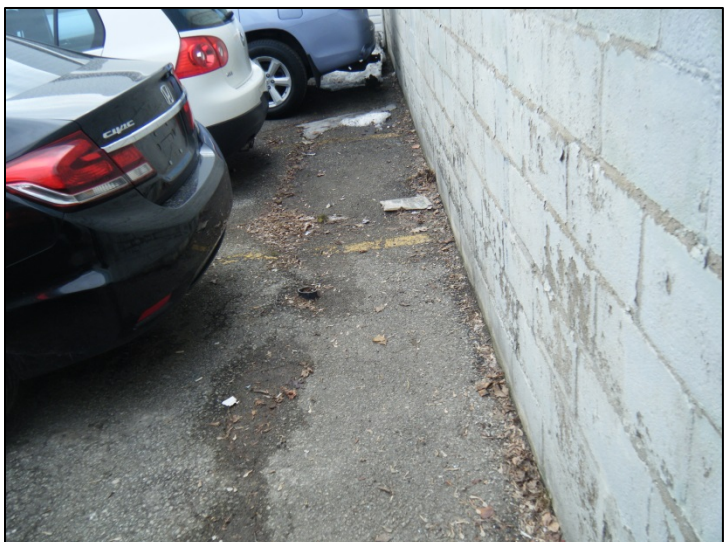
Photo 18:

View of one of the three pipes cut near flush with the asphalt, along the west Site boundary at 3359 Lakeshore Boulevard West. Photo taken facing south.
